DOT/FAA/AR-97/88

Crack Growth-Based Predictive Methodology for the Maintenance of the Structural Integrity of Repaired and Nonrepaired Aging Engine Stationary Components

April 1999

Final Report

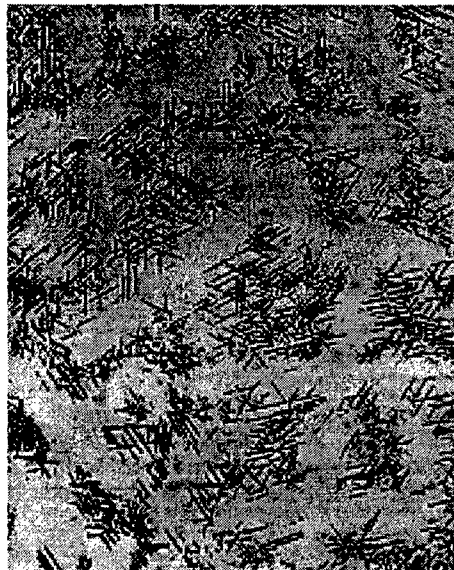
FIGURE 27. MICROSTRUCTURES FROM WROUGHT IN718 TUNGSTEN INERT GAS WELD HEAT AFFECTED ZONE EXPOSED TO STANDARD HEAT TREATMENT AND 30 SIMULATED REPAIR (1700°F) CYCLES
